PAVEMENT REHABILITATION RESONANT RUBBLIZING

RUBBLIZATION OF PCC USING A RESONANT BREAKER JANUARY 2018

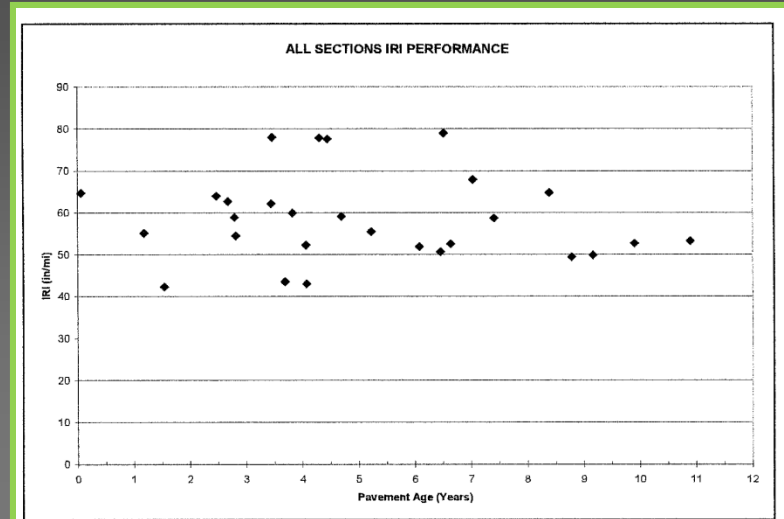
Figure 4.3 IRI vs. Pavement Age.

- ✓ Long life for surfaces – 22+ years
- ✓ smooth driving conditions
- ✓ Rubblization eliminates reflective cracking and dramatically reduces surface defects

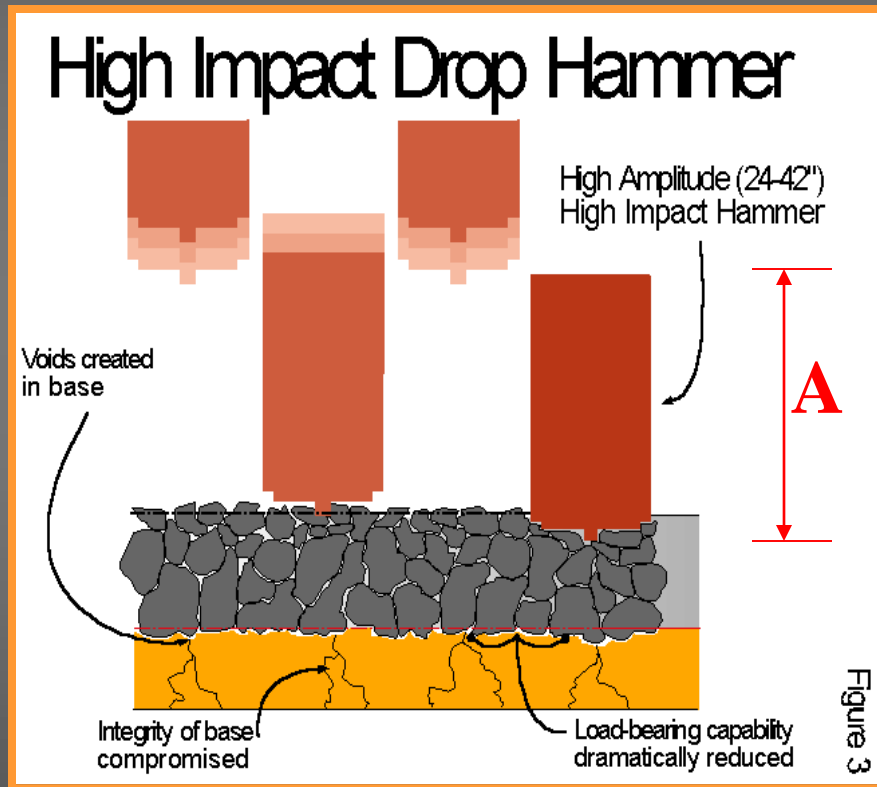
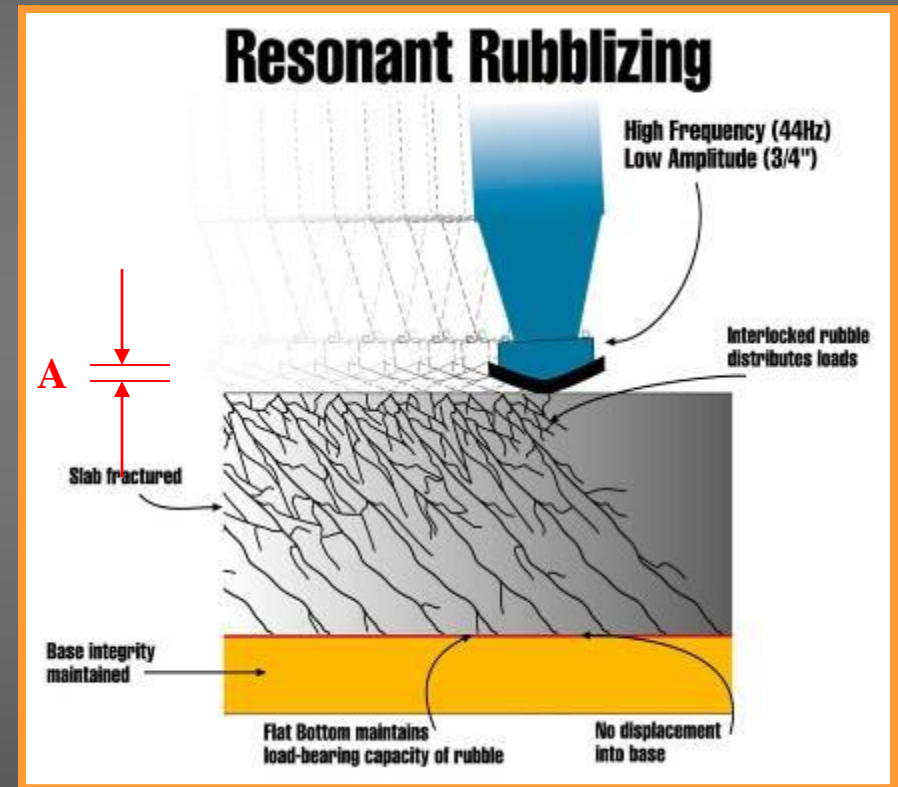
“Rubblizing” doesn’t affect the base integrity due to the low amplitude

High Amplitude
Damage to Base / Utilities

Low Amplitude
No Violation of Base / Utilities

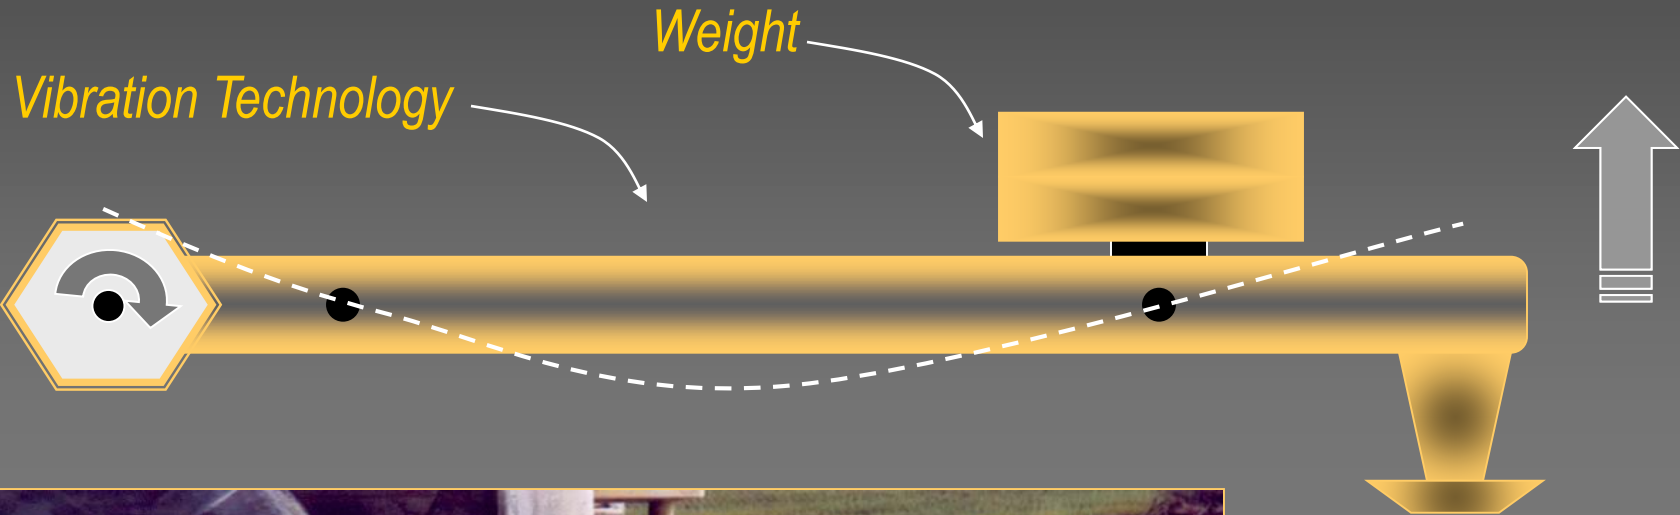
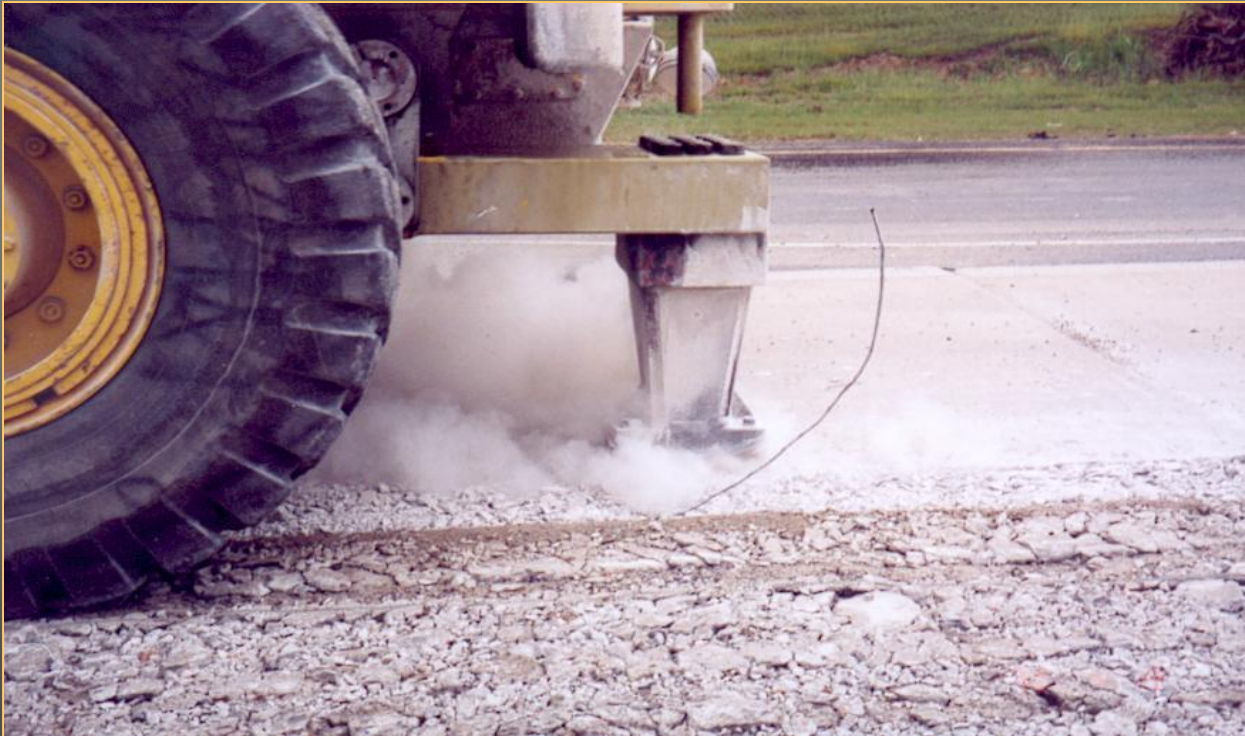
Description of Resonant Beam

Frequency 44 Hz

**Amplitude 13-19
mm (3/4")**

- **Strikes PCC 44 Times per Second**
- **900 kg. of Pressure Per Strike**
- **Beam Weighs 4080 kg.**
- **Raises 13-19 mm. Per Strike**
- **Machine Speed is at approx. 5-8 km/h**
- **Breaking Area is 25.4 mm. wide**
- **Average Rubblized Per Day: 6,000 m²**

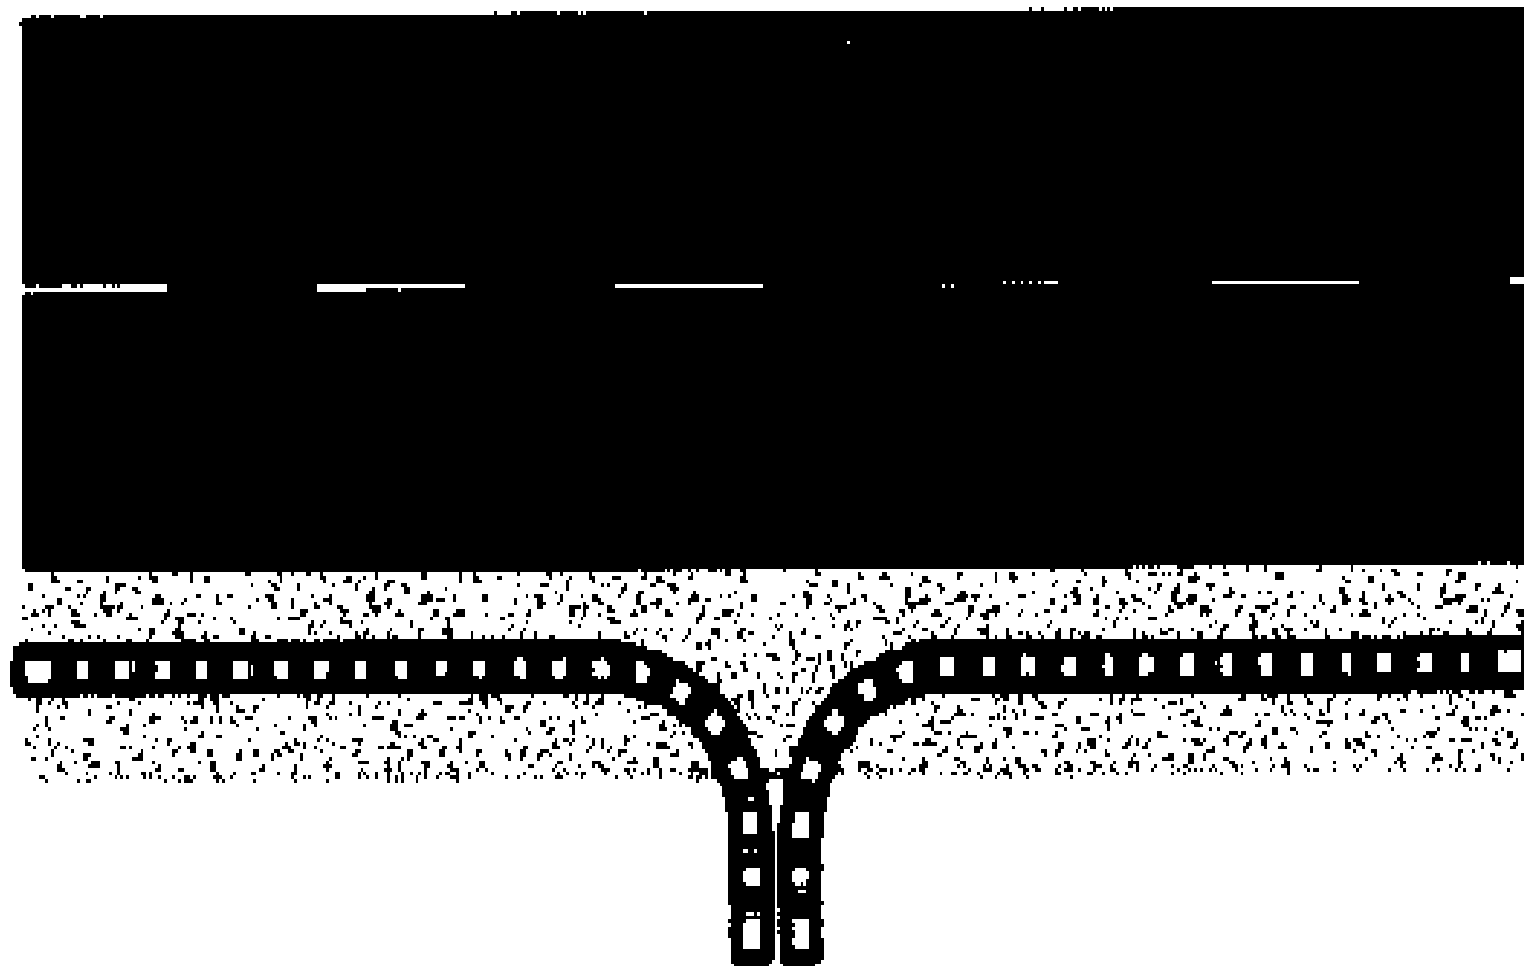
Dual Outlet

Dual outlets - One each direction

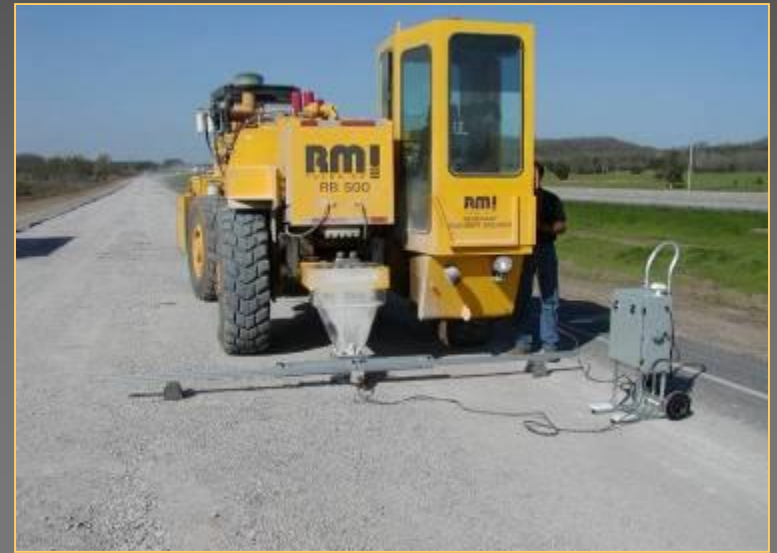
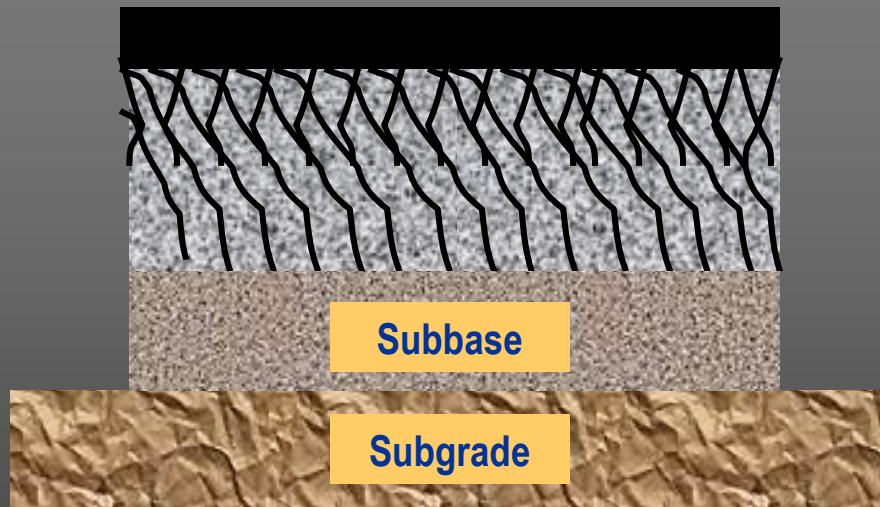
The Modulus of the Rubblized Concrete depends on the Thickness, Subbase and Subgrade. Typically Rubblized Concrete is 2.5 Times Stronger than any Granular Material.

$$E_4 > E_3$$

$$E_3 > E_2 \quad \text{Where } E_3 = f(E_2)$$

$$E_2 > E_1 \quad \text{Where } E_2 = f(E_1)$$

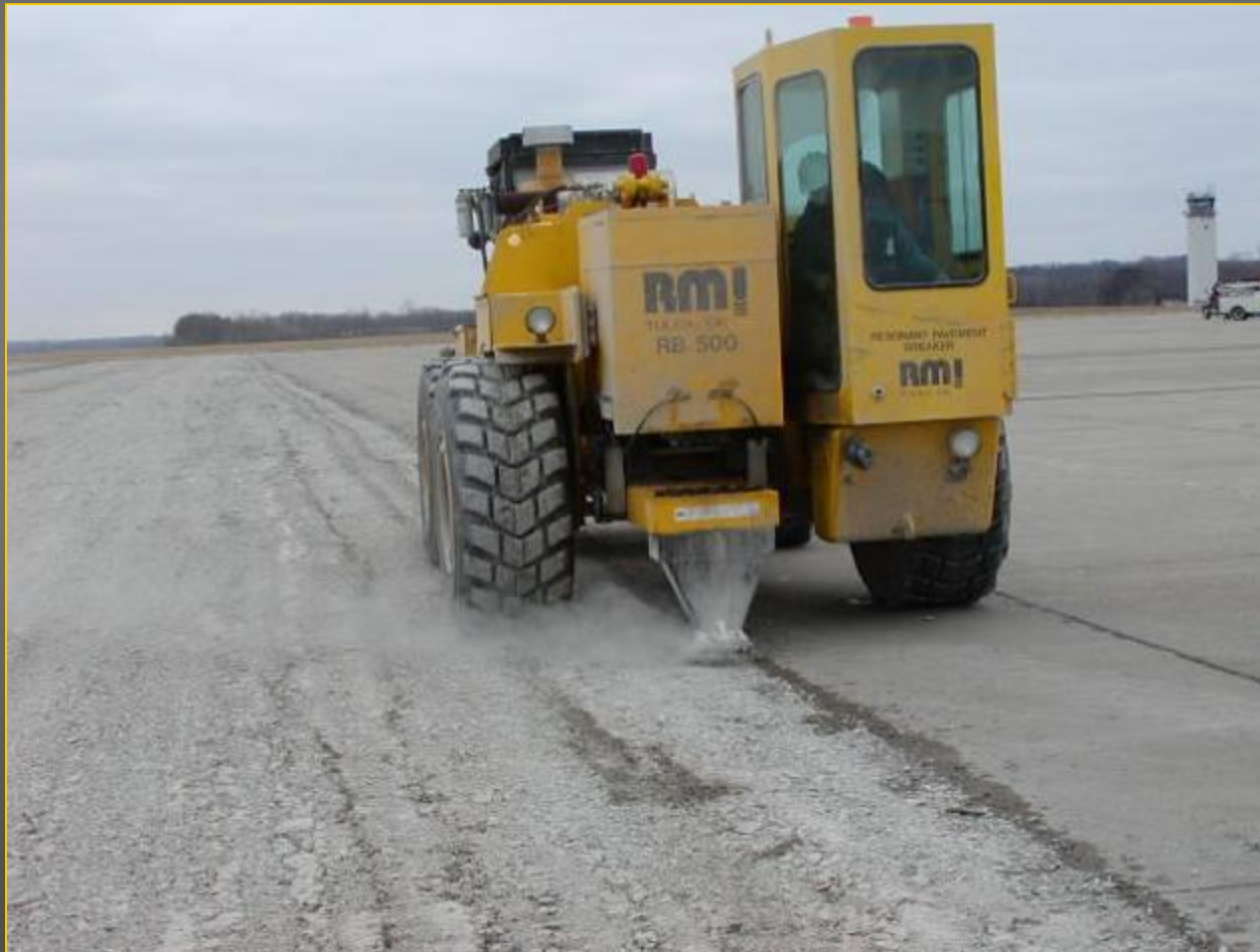
➔ Resonant Rubblizing

- Capable of Rubblizing up to 60 cm.
- Ideal Distance Per Run – 1.6 km. / One Lane Wide
- Speed of Resonant Machine 5 – 8 km/h

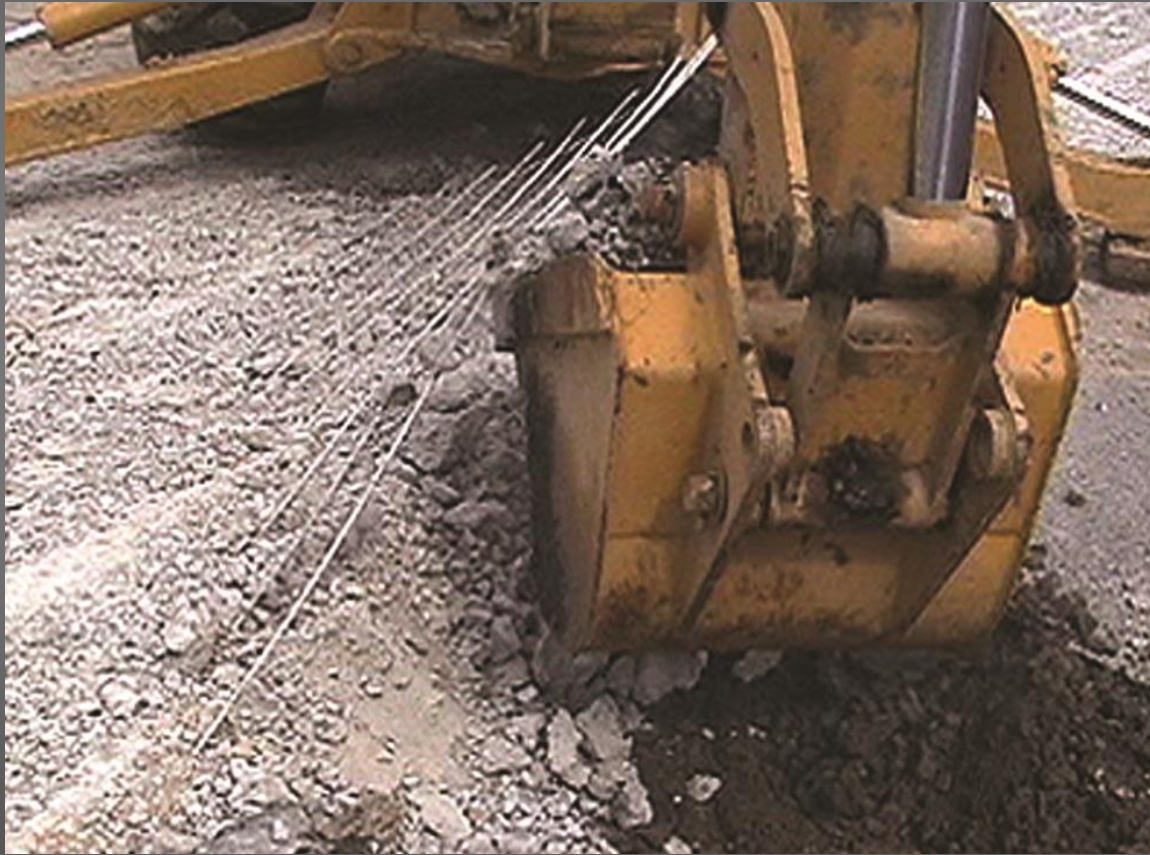
Test Pit

Confirm Specification and Debonding

Fracture Pattern at Memphis International Airport

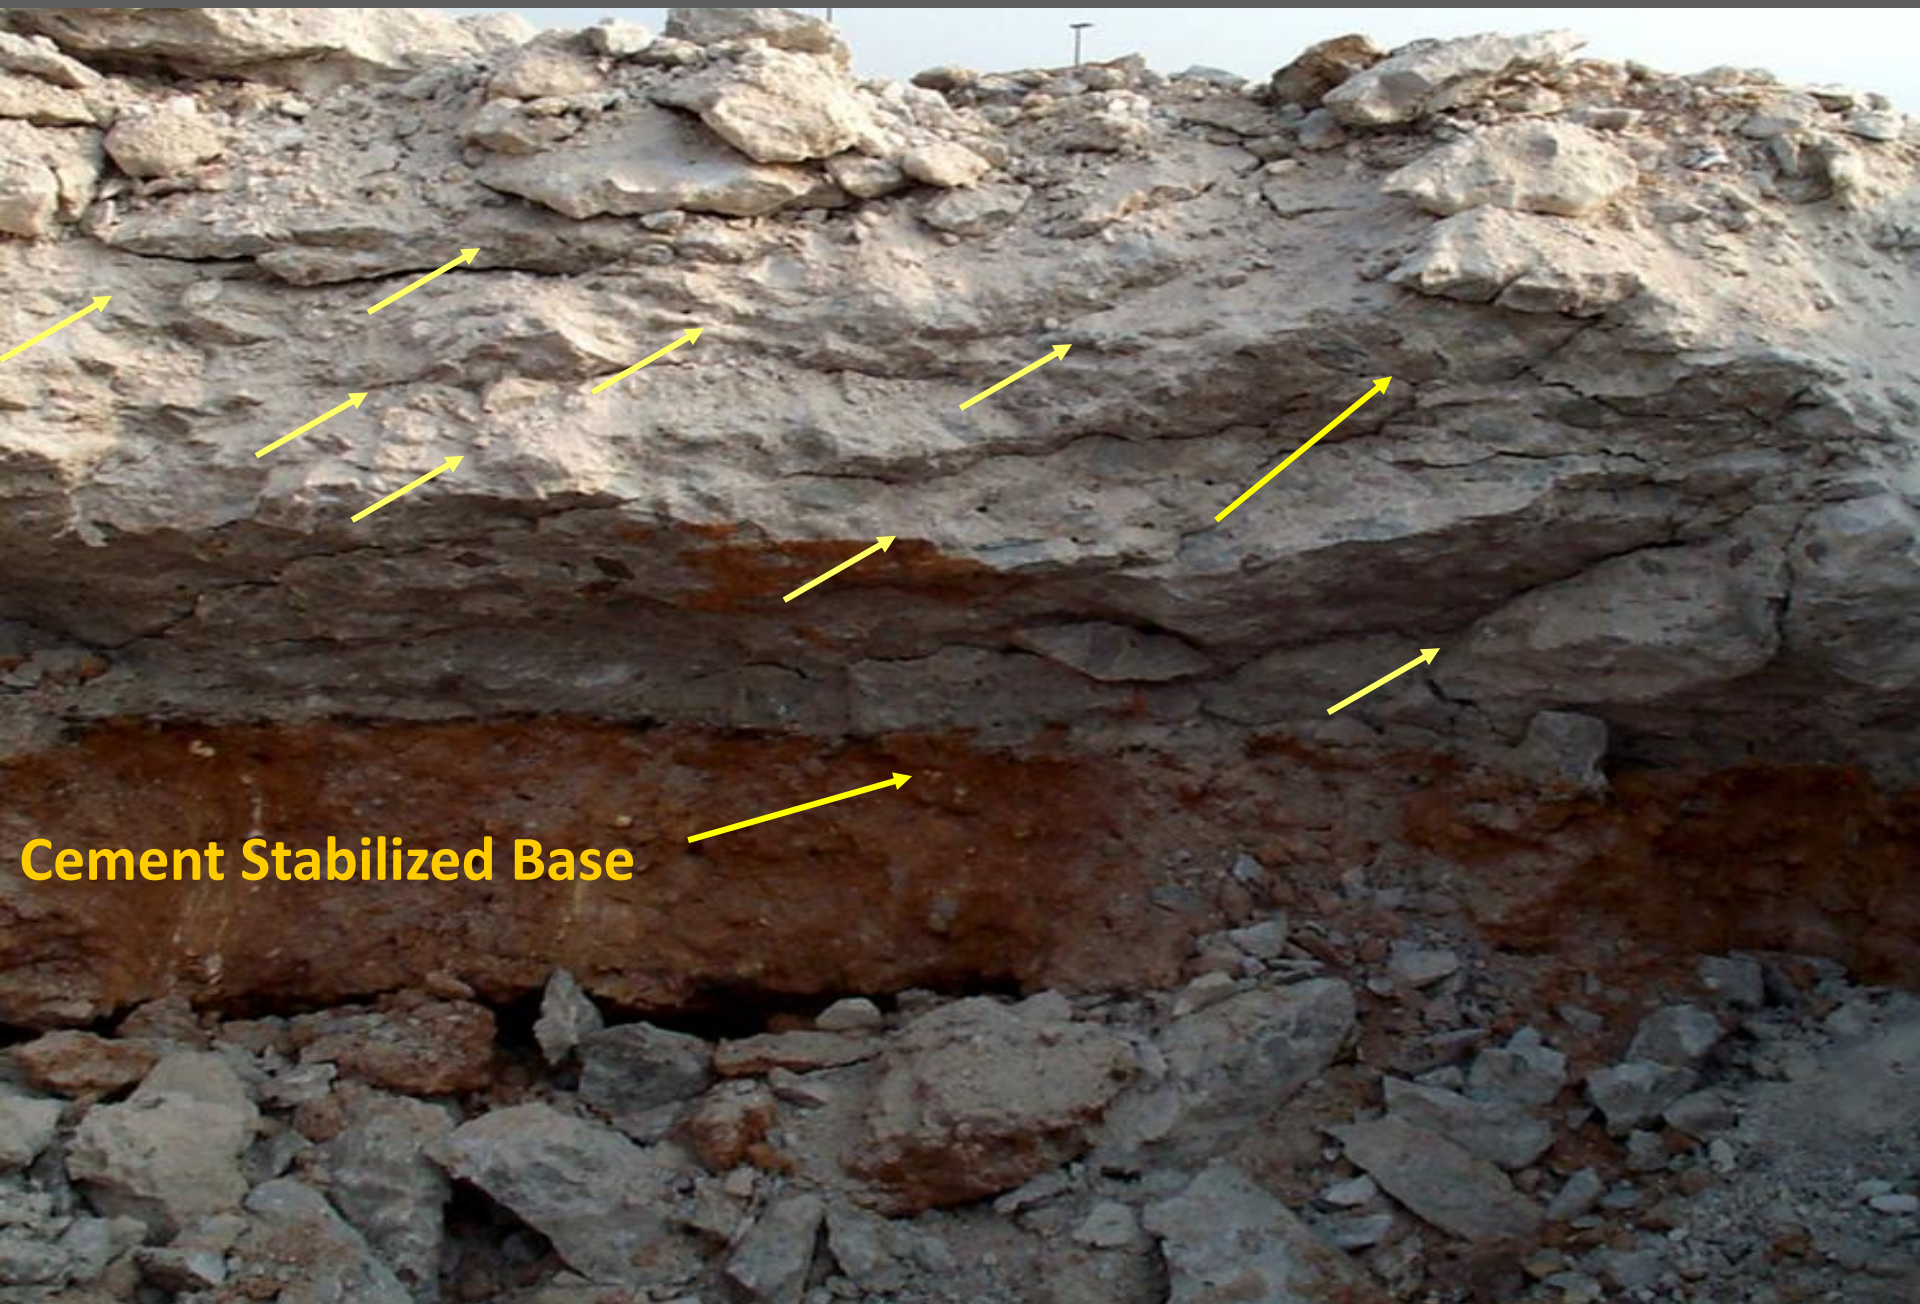
Cement Stabilized Base

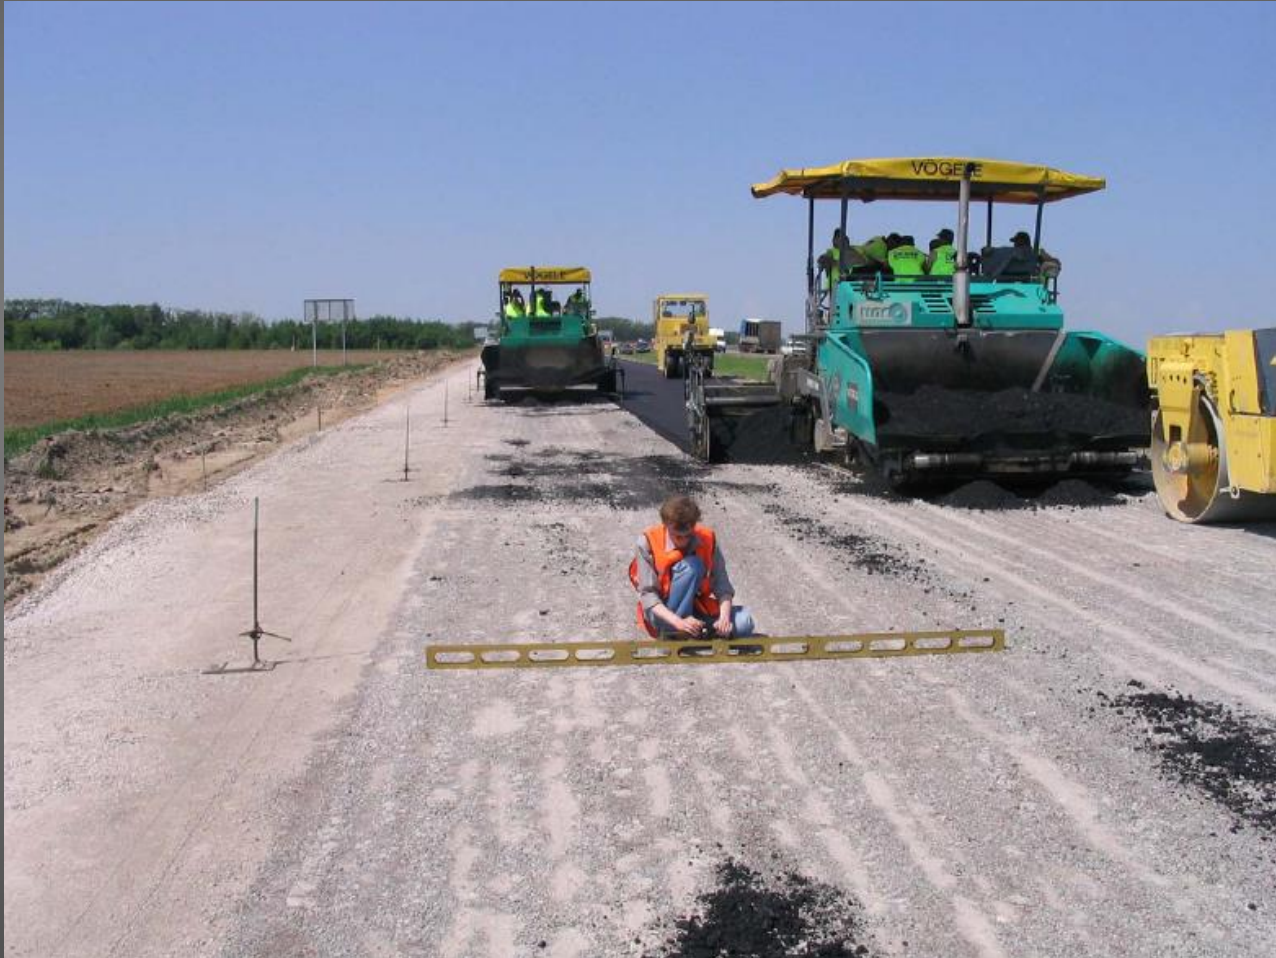
Rubblized Slab Prior to Rolling

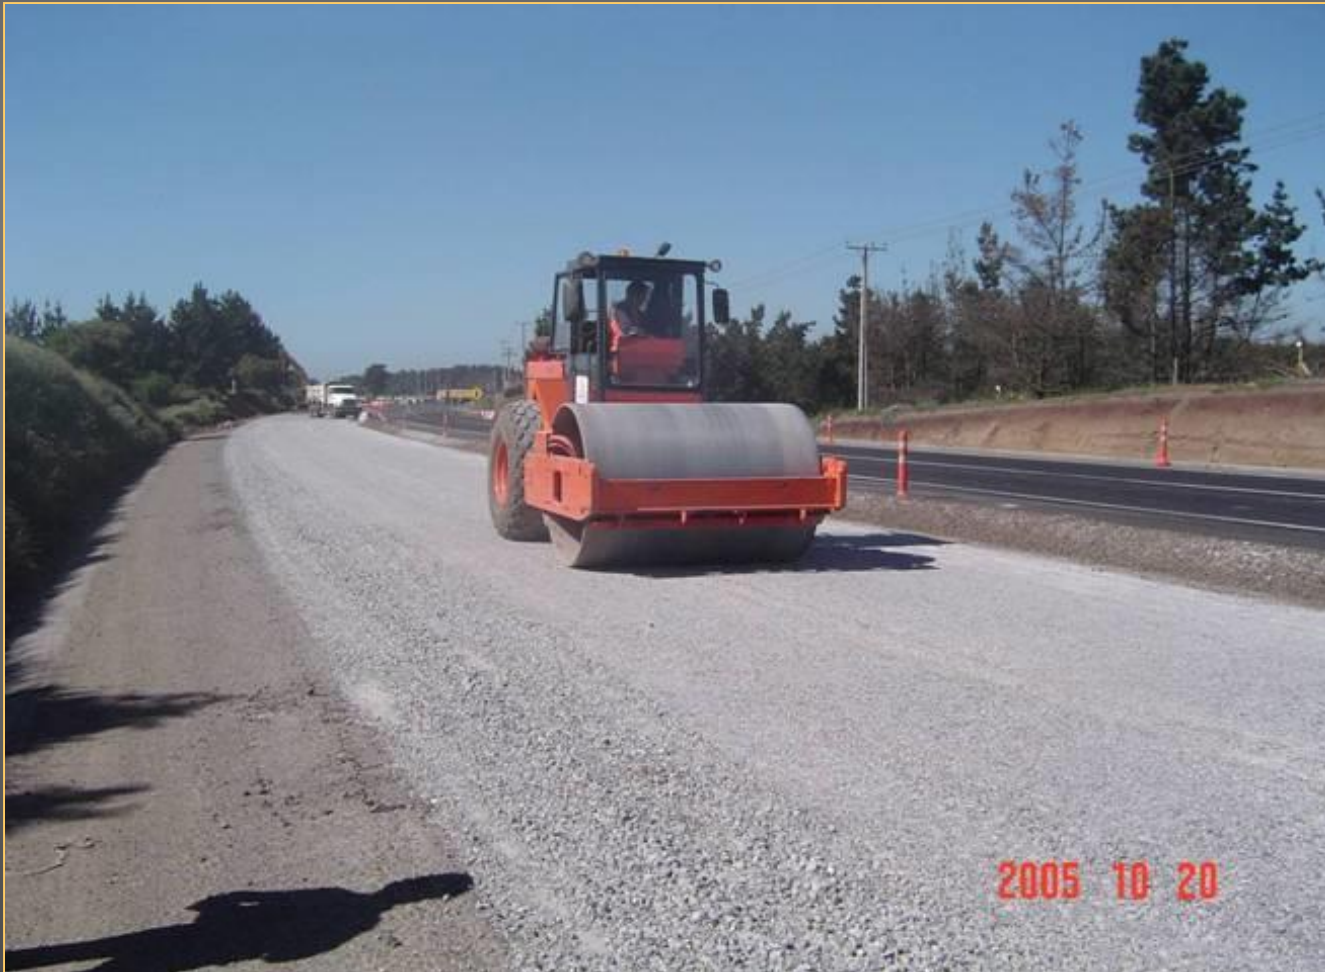
➔ Rolling

- 10 Ton High Frequency, Low Amplitude Steel Drum Roller (3 Passes)
- Only Equipment Necessary After Rubblization
- Not Recommended to Drive on Prior to Asphalt Overlay

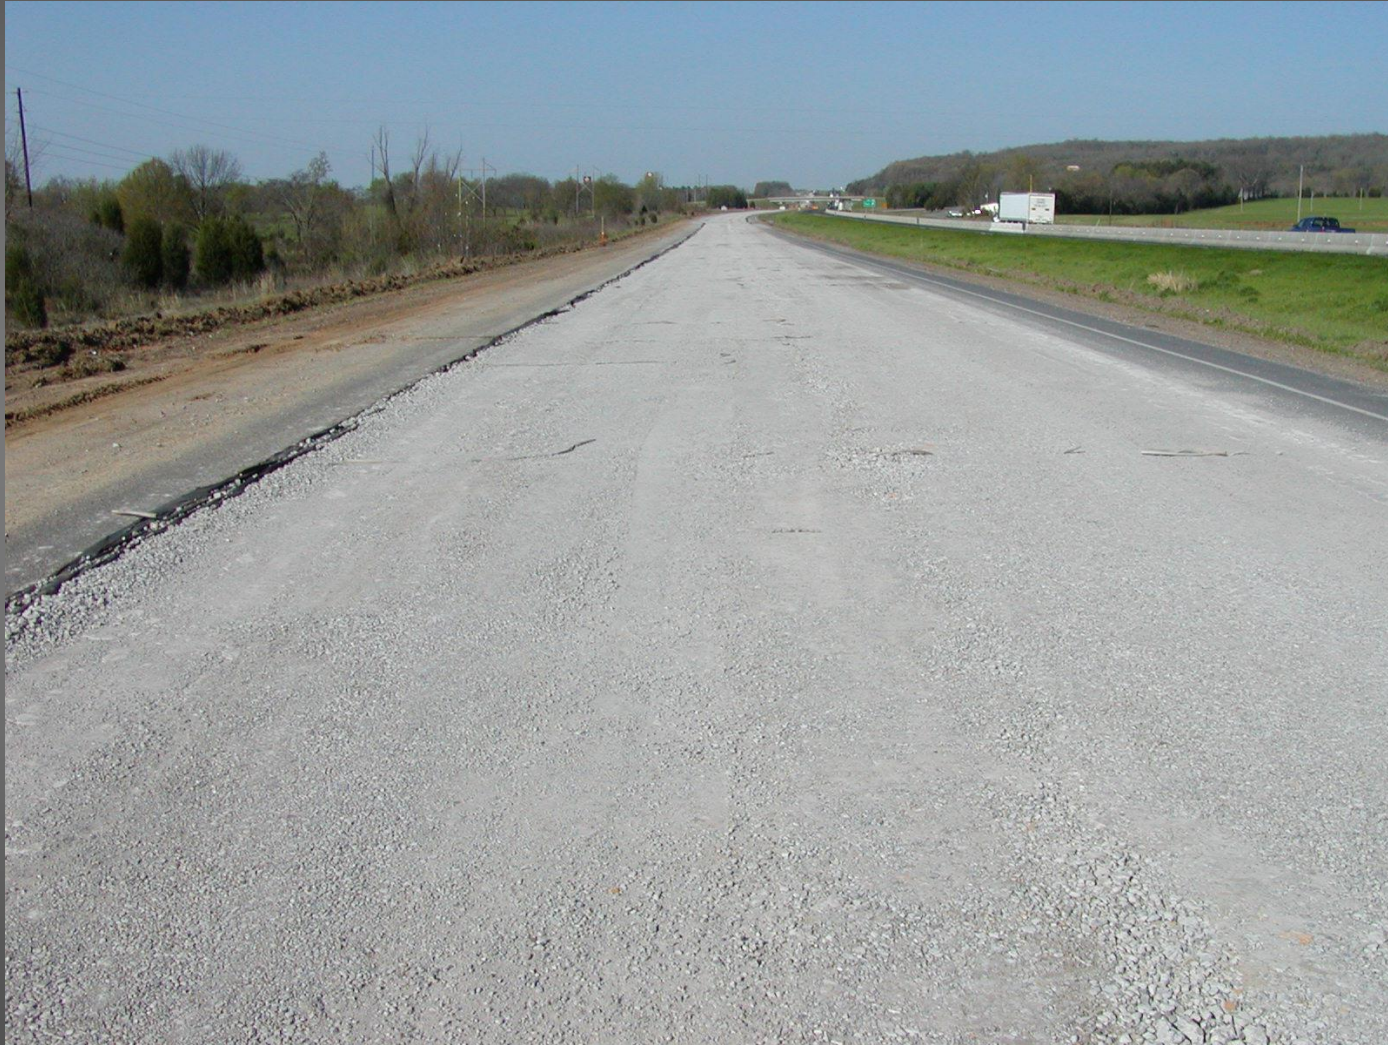
➔ Result

- Surface after compaction and before overlay

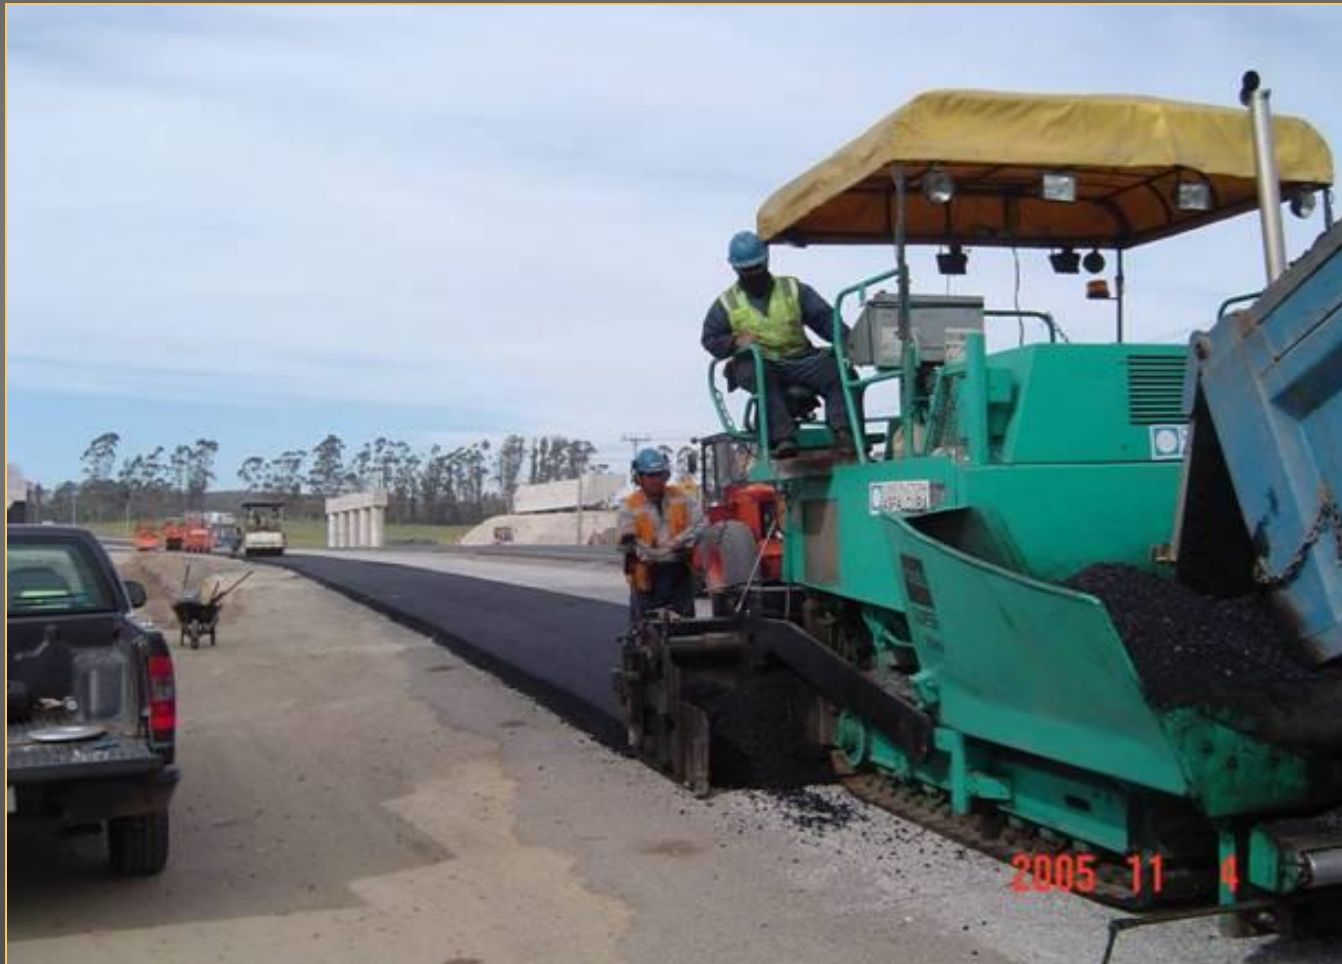
➔ Asphalt Layer

- Leveling Course on First Lift with Ability to Open Traffic
- No Primer Required on Rubblized Layer
- Minimum of 12 cm. of Asphalt Overlay
